Fawn Lake Dam, ID Number PA-00693.
Schuylkill River Basin, Plum Creek,
Schuylkill County, Pennsylvania.
Phase I Inspection Report.

PHASE I INSPECTION REPORT
NATIONAL DAM INSPECTION PROGRAM

PHASE I INSPECTION REPORT
NATIONAL DAM INSPECTION PROGRAM
FAWN LAKE DAM
NATIONAL ID #PA 00693
DER ID #54-175

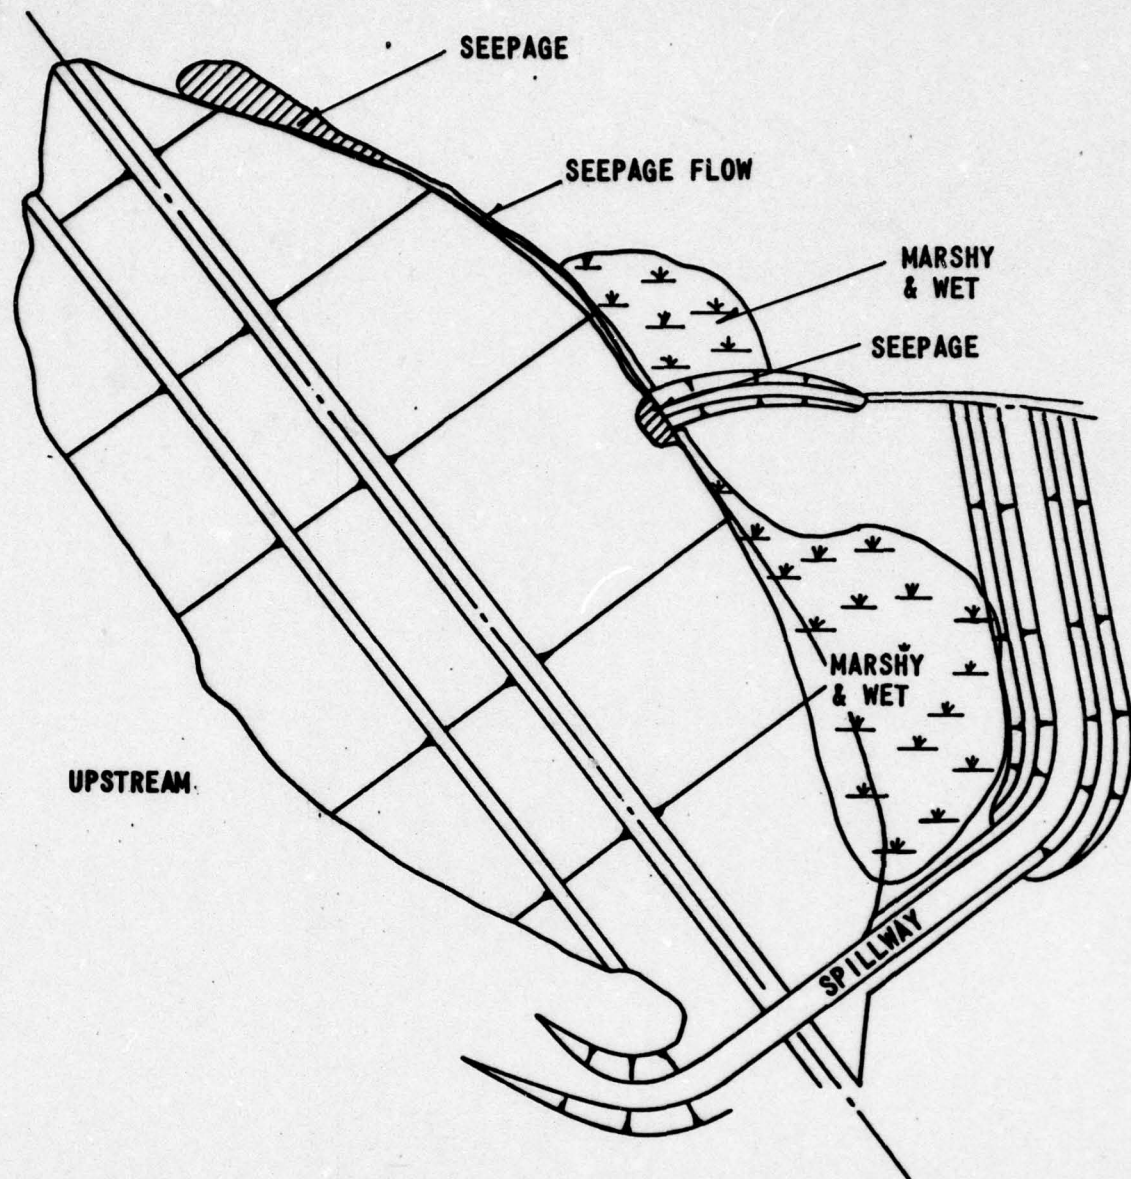
SEEPAGE LOCATION PLAN
FAWN LAKE DAM
SHEET 5a OF 11

See sheet 5a. Clear seepage was observed along the downstream embankment contact with natural ground. Concentrated areas of seepage were observed on the left abutment initiating slightly below the apparent normal pool and around the pond drain pipe outlet structure. The areas of concentrated seepage on the left abutment is not covered with graded filter stone. Black willow trees mark the edge of the seepage zone to the right of the discharge structure. The area immediately downstream of the embankment toe was gradually wet and marshy with areas of standing water noted. The seepage rate, erosion and turbidity should be monitored.

*NOTE: Due to the type of seepage occurring,
the rate of seepage could not be
estimated.*

As discussed in Appendix B, seepage and wet marshy areas were noted. These areas should be monitored for turbidity, erosion and change in flow rates.

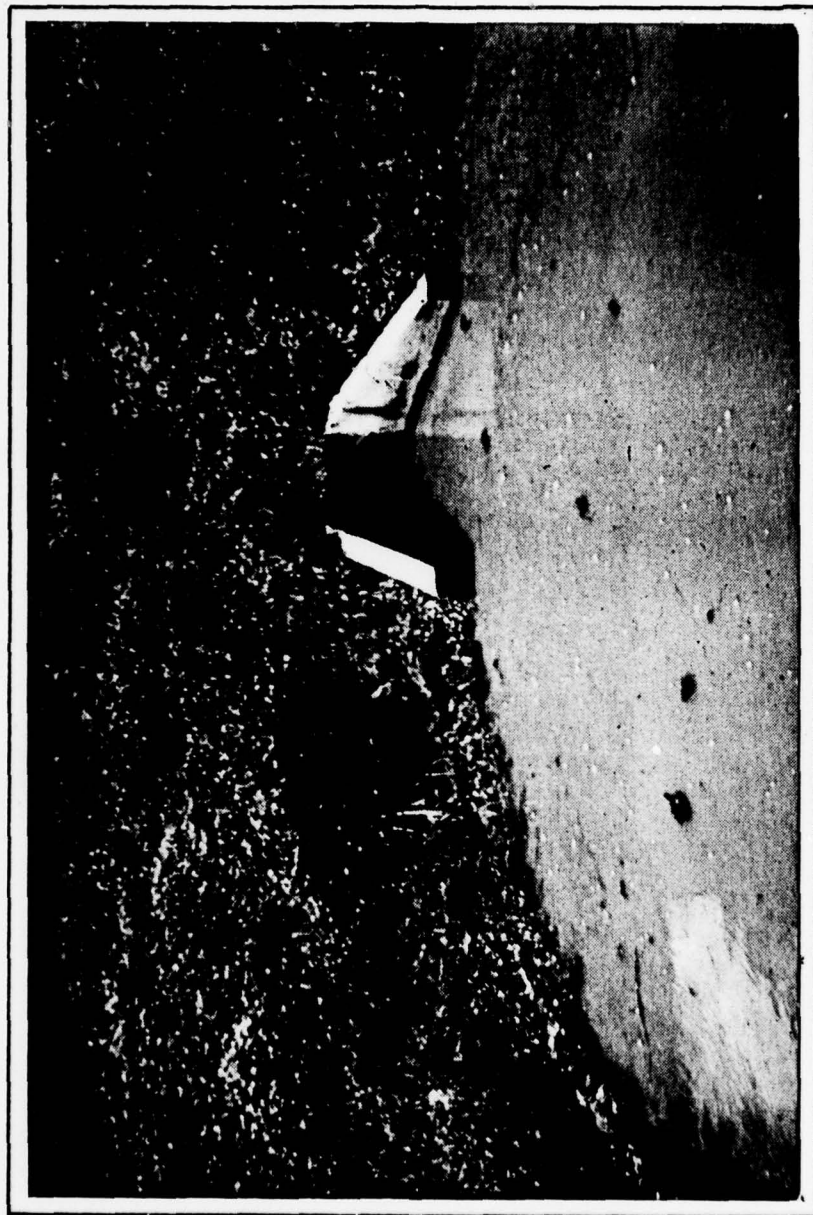
VIEW OF POND DRAIN OUTLET SYSTEM.
WATER IS MUDDY BECAUSE DRAIN WAS
OPENED TO TEST SYSTEM.

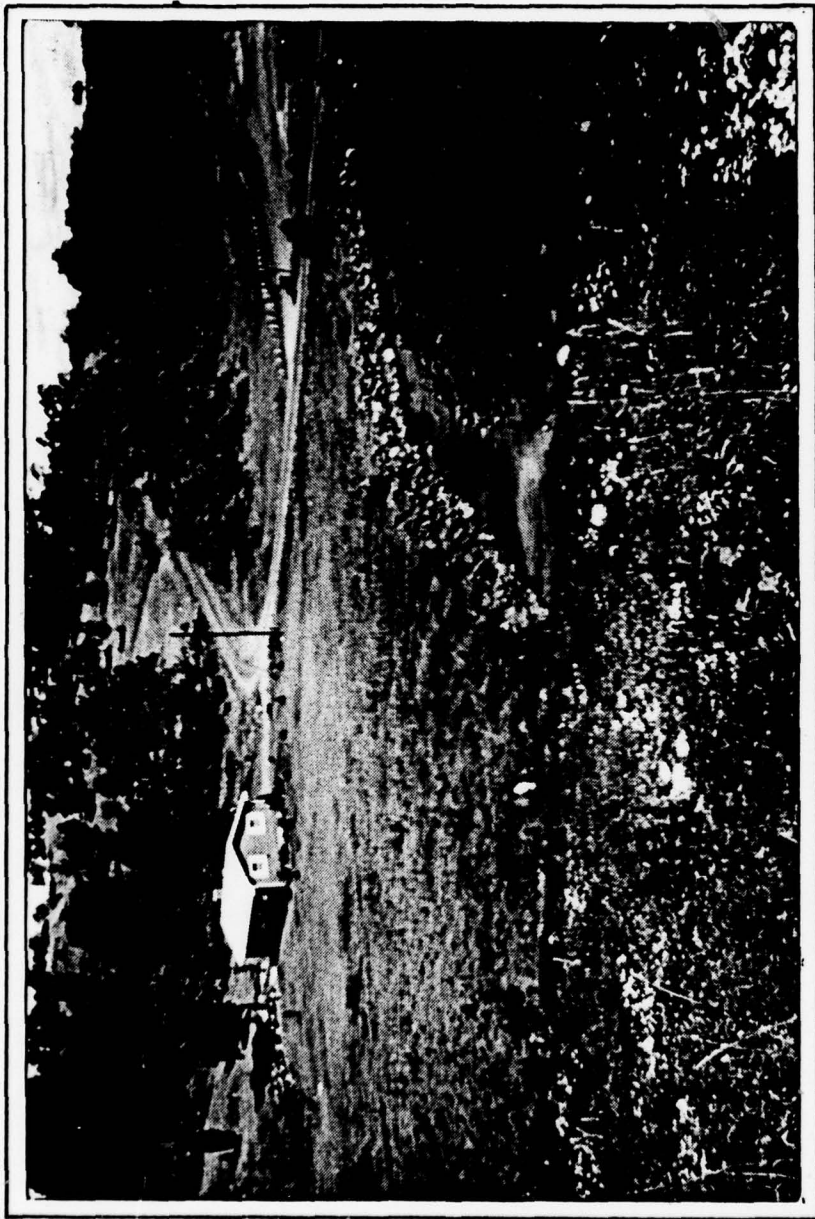
PHOTOGRAPH NO. 3

VIEW OF POND DRAIN OUTLET CHANNEL.
NOTE DISCHARGE UNDER ROADWAY AND
HOME ON LEFT, SUBJECT TO FLOODING.

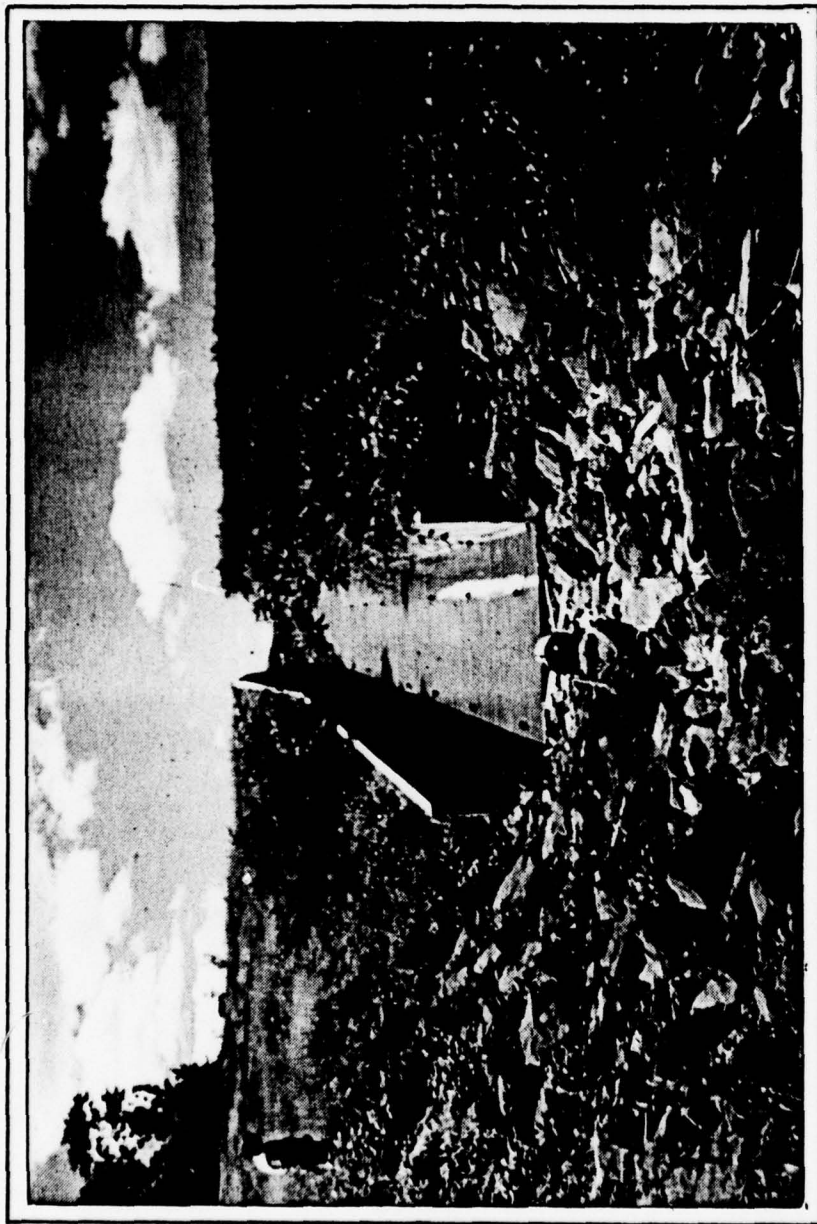
PHOTOGRAPH NO. 6

LOOKING UPSTREAM THROUGH PRINCIPAL
SPILLWAY. NOTE DENSE GROWTH ADJA-
CENT TO WINGWAY WHERE SOIL IS WET.
